# Corps Keeps Public Water Clean Naturally

Watershed protection projects allow minimal filtration of drinking water supplies.

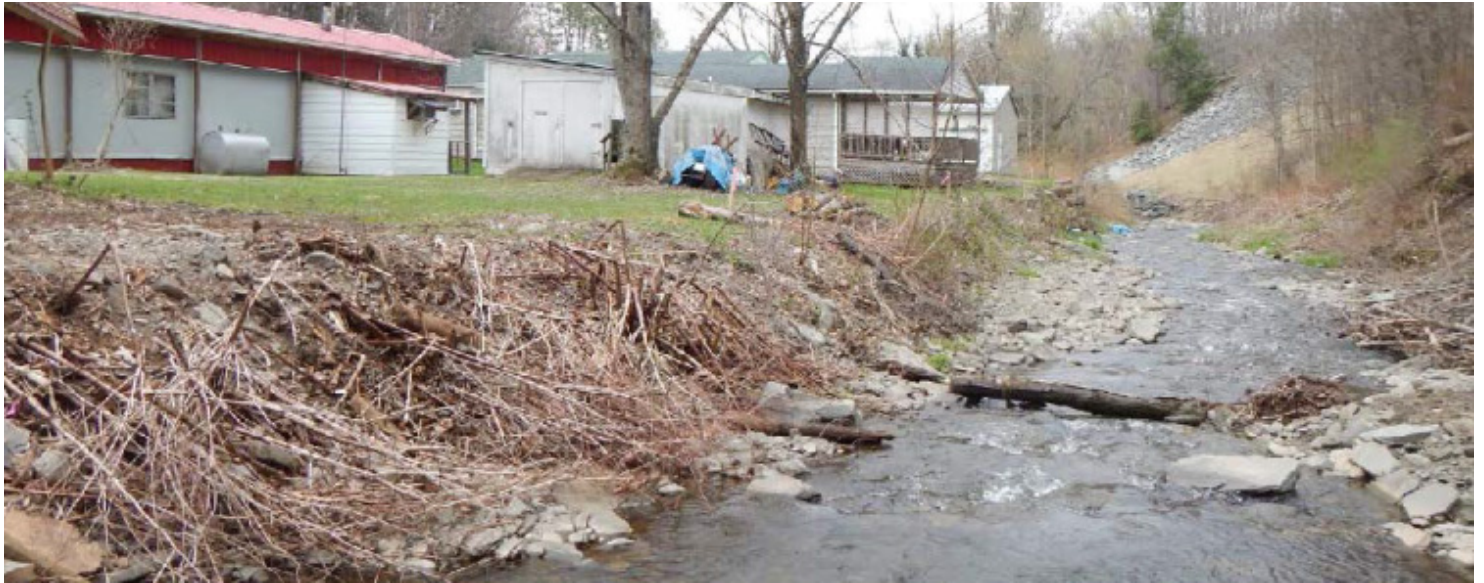
Third Brook was highly susceptible to failure after a major flood.

The Town of Walton is in Delaware County. A while back, a major flood devastated the rural town and damaged many homes and businesses, resulting in approximately \$30 million in losses. Trees along streams were uprooted and fell into the streams, were carried down the waterways, and clogged several bridges. The fast-moving water had nowhere to flow but out onto the streets, flooding businesses and homes.

When stream banks start failing, all of the materials that used to be on the bank become potential contaminants to the water that eventually becomes New York City's drinking water. This flood didn't cause water contamination, but such events could.

"These slope failures can do a lot of damage to the water," Salim said. "When the slopes or embankments get eroded, a lot of sediment and soil enters the stream. These sediments cause turbidity in the water. It then flows into the reservoir and eventually adversely effects New York City drinking water."

One of the streams that was severely eroded during this flood was the Third Brook. Third Brook flows into the West Branch Delaware River, which in turn flows into the Cannonsville Reservoir. This reservoir provides 97 billion gallons of water to New York City's drinking water supply.

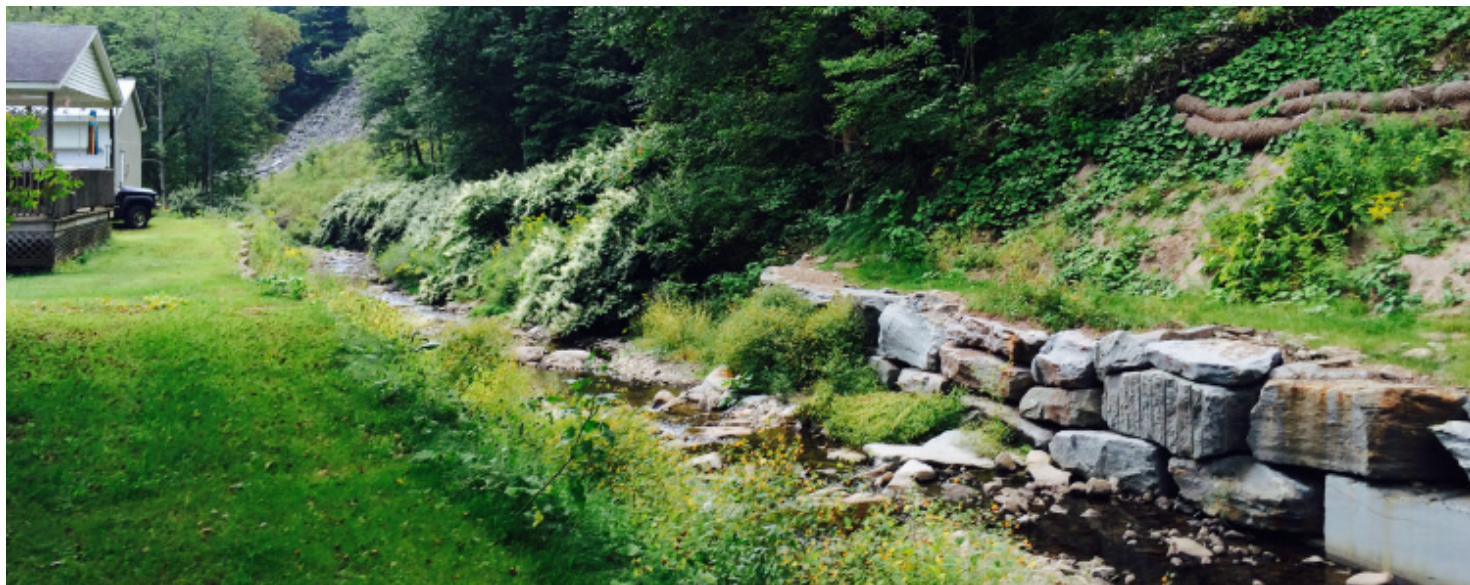
Third Brook today is stabilized and vegetated.

According to Graydon Dutcher, project manager and administrator of the Delaware County Soil and Water Conservation District, they stabilized the toe of the failing stream banks with stacked rock walls or rock rip rap and provided protection to the streambed with the placement of in-stream structures such as boulder riffles.

"We had to use large rock to stabilize the toe of the banks and the stream bed itself because the stream has no floodplains," Dutcher said. "All of the floods, large and small, are contained within the limited channel. This produces very rapid stream flow. Wherever it was possible, we buried the rocks and planted around them with native vegetation. This combination creates a more diverse and flood resilient stream corridor. We also hydro-seeded all of the bare slopes and planted willow stakes and native trees along the floodplain, which provides for habitat and increases the stream's long-term stability."

Salim added, "This vegetation helps stabilize the slopes. The roots stabilize the soil and they can also absorb contaminants before they reach the stream, providing us cleaner water."
