# Erosion Control

# Project Profile

## Protecting Water Quality Has a Positive Trickle-Down Effect

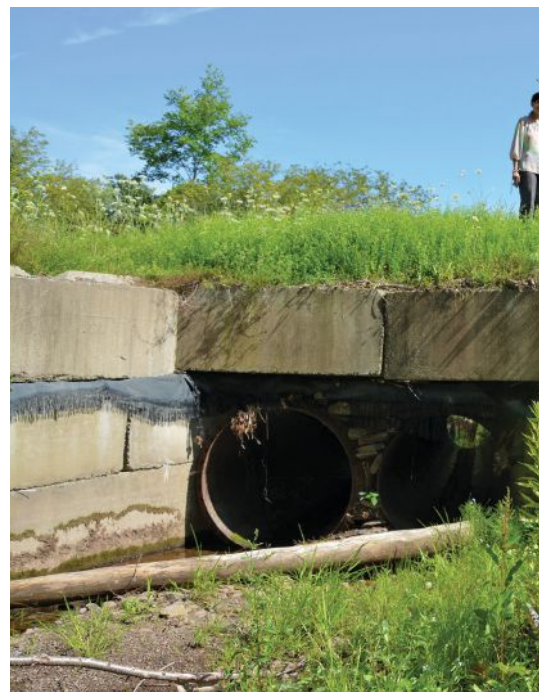
This 2016 photo shows the old culvert, which had two circular pipes with a total diameter of 36 inches. Pictured are Rifat Salim (left) and JoAnne Castagna.

A damaged culvert can jeopardize the quality of this water. The previous culvert was undersized and had been damaged by years of stormwater runoff. During storm events, high water from Lake Brook streamed in and overwhelmed the undersized culvert, which caused the water to overtop and flood the road.

Graydon Dutcher, stream program coordinator with the Delaware County Soil and Water Conservation District, says, "The previous culvert was two circular pipes with a total diameter of 36 inches. The new culvert is almost seven times larger."

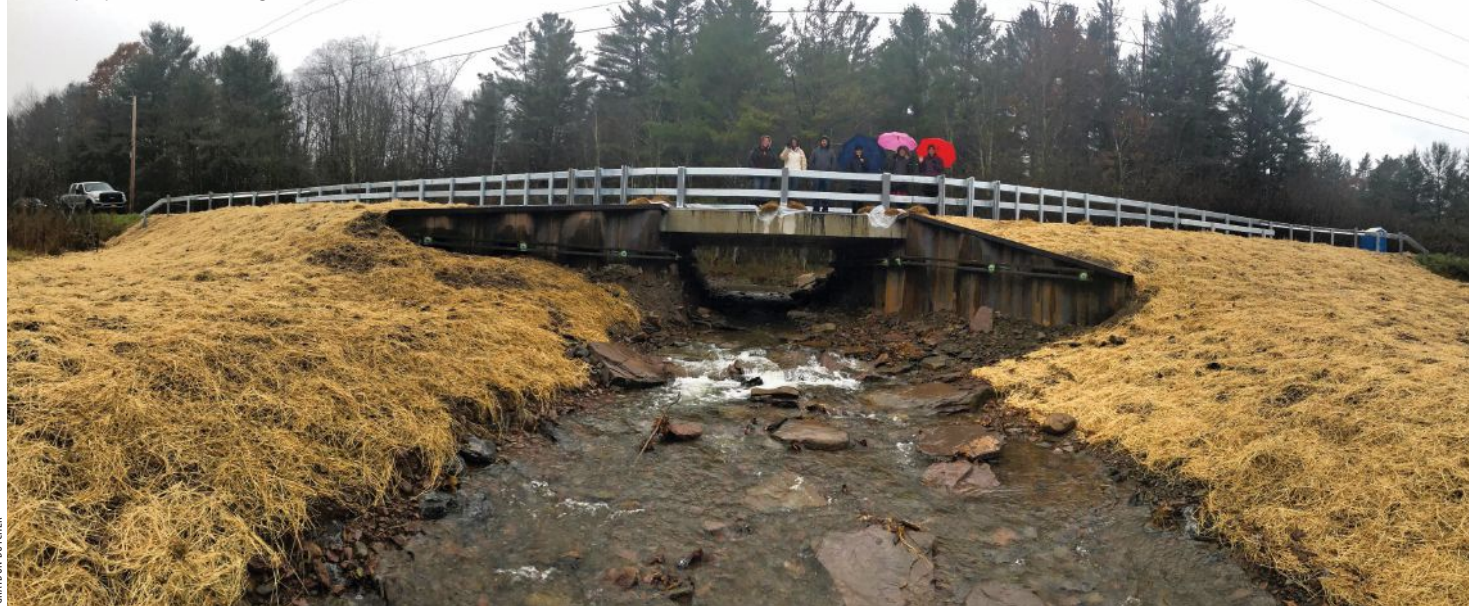
The project team looking over the new culvert

The new culvert is larger, allowing a greater amount of water to flow through and reducing the chances of flooding during storm events.

To further control stormwater runoff, the streambanks along the culvert were restored and stabilized. Rock was placed along the banks to prevent fine sediment from running into the brook.
