civil + structural ENGINEER

NEWS ON TAP: NEW YORK CITY DRINKING WATER

By JoAnne Castagna, Ed.D.

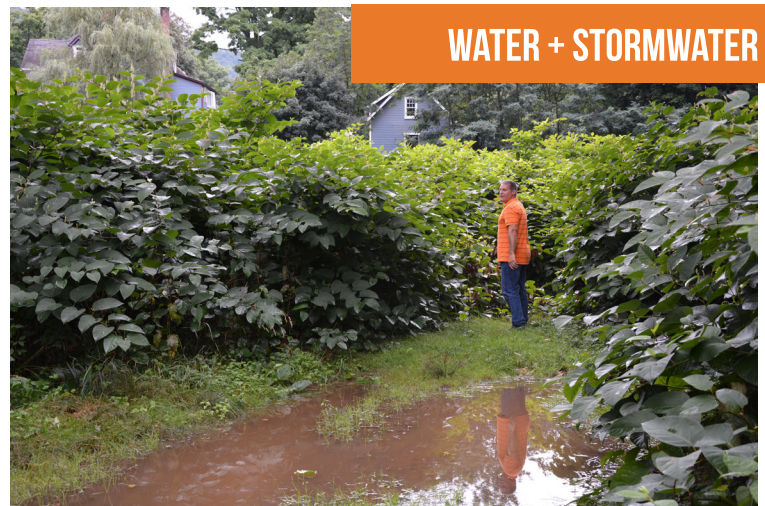
Before: Graydon Dutcher walking Army Corps personnel through the tall invasive plants on the Walton floodplain in the Town of Walton in 2016.
Photo: JoAnne Castagna, public affairs.

Over the years, the floodplain was filled with 10-feet of fill. This raised and hardened the land, killed natural vegetation and caused invasive plant species to flourish, and eroded the river's edge causing soil and trees to fall into the water.

As a result, when the river floods the water that would naturally be absorbed, filtered, and transported by the floodplain is unable to, so floodwaters back up and stay trapped on the village streets, flooding homes and businesses.

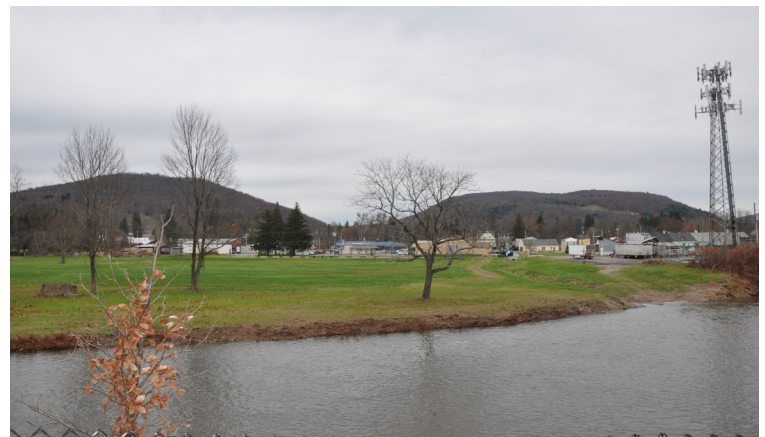
After: The completed Walton floodplain project in late 2019.
Photo: JoAnne Castagna, public affairs.

"Today, the floodplain is on its way to becoming healthy," said Graydon Dutcher, stream program coordinator with the Delaware County Soil and Water Conservation District. "The fill was removed and recycled."

The village and town also mowed and graded the land to the correct elevation and slope to allow water to spread out onto the floodplain, instead of overtopping the banks and flooding nearby businesses.

Afterwards, grass was planted on the floodplain and native vegetation and shrubs were planted along the river including a mix of Maple and Ash trees.

Dutcher said, “Now flood waters will drain from the town’s streets, building rooftops, and parking lots and filter through the vegetation before entering the river.”

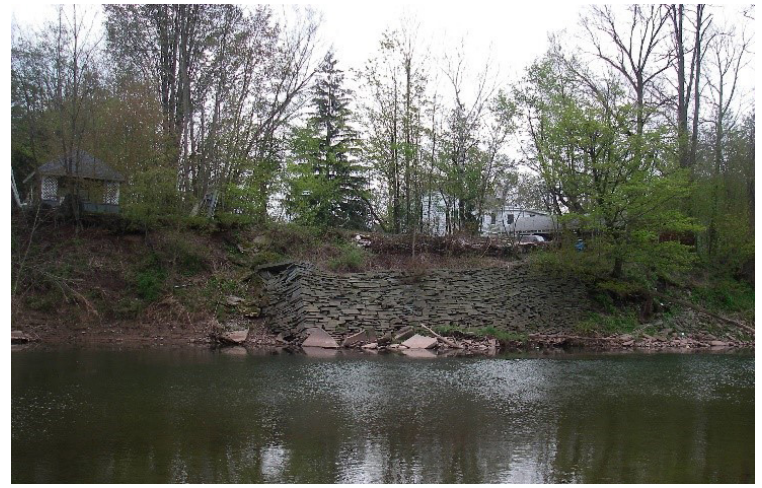
Before: Stone wall sliding down into the West Branch Delaware River at South Street. Photo: DCSWCD.

Over the years, South Street, which is lined with a few houses, has been slowly eroding down into the river.

This has caused the river’s edge to erode, causing trees and soil to fall into the water and has created tension cracks in the street’s asphalt.

To stabilize the river’s banks and prevent the street from continuing to shift down, 40-foot steel sheet pile was installed along the bank that extends 30 feet below ground.

Dutcher said, “If we didn’t perform the sheet pile work, this whole area would have cleaved off. We really had to stabilize this bank using hard armoring, which is something we don’t typically do, but in this case it was really needed.”

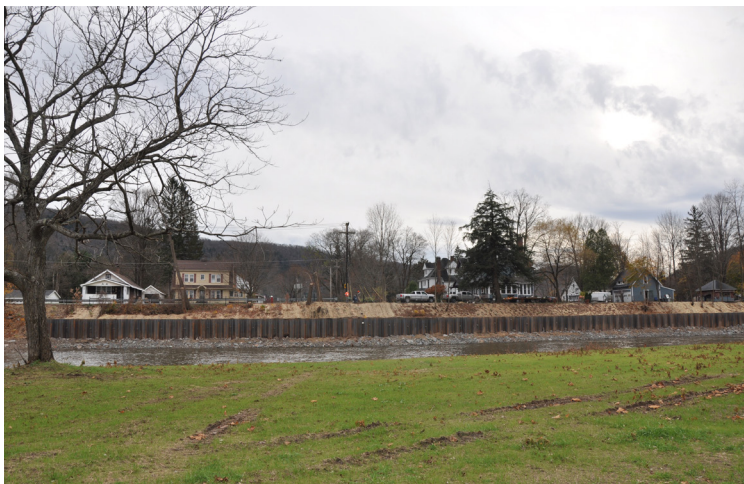
After: The West Branch Delaware River and completed South Street Bank Restoration Project in the Town of Walton, as seen from the Walton floodplain.
Photo: JoAnne Castagna, public affairs.

To further stabilize the bank and control streambank erosion, loose stone was placed at the edge of the river. The stones slow down the stream along the sheet pile and reduce potential damages downstream.

Native vegetation was also planted near these stones and at the bottom area of the sheet pile. “We also plan on growing creeping vines along the top of the sheet pile, so it looks more natural when grown out,” said Dutcher.

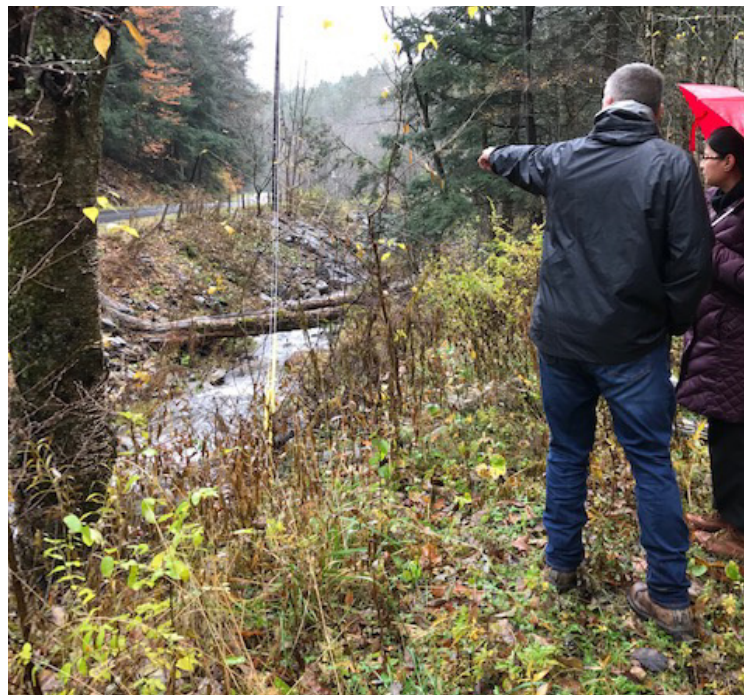
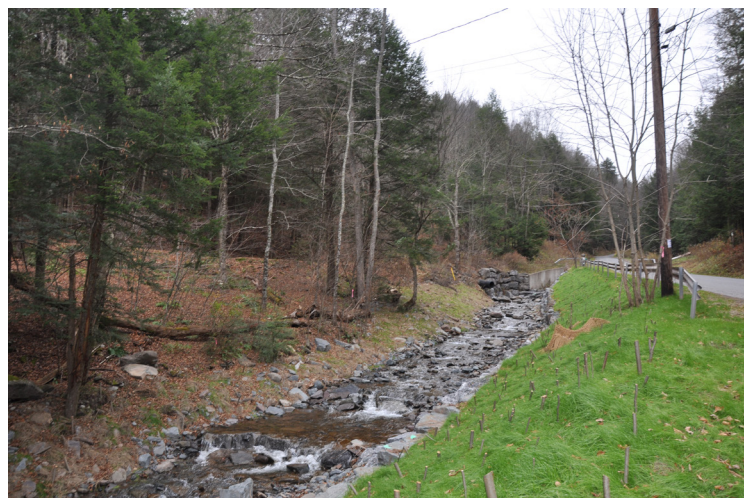
Before: Graydon Dutcher showing the Army Corps' Rifat Salim the eroding Close Hollow streambed and bank in the Town of Andes in 2018.
Photo: JoAnne Castagna, public affairs.

These streams were eroding, causing trees and soil to fall into the water.

To stabilize the streambanks, the slopes along the sides the streams were cleared of the falling trees and debris and the bottom of the slopes and bed of the stream were reinforced with rock. The bare slopes were then hydro-seeded and planted with willow stakes and native trees.

While the plants are taking root, a thick coconut geo mesh fabric was laid along the banks to protect the growing plants and to prevent soil from running into the streams.
